## Project Deliverable 6.2

### Locating excess water in a small sewer system – The case of Snogeröd, Höör Municipality, Sweden

**This case study forms part of the Interreg-project STEP, South Baltic Program and is based on an internal report compiled by Mittskåne Water**

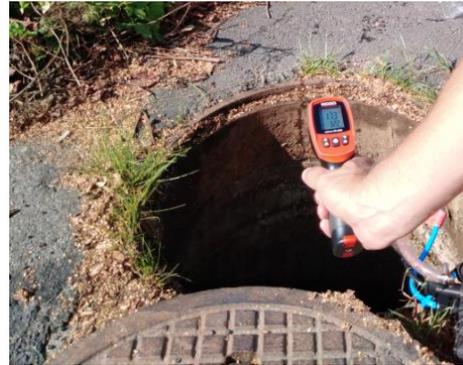
Figure 3. The temperature pistol was directed against the wastewater stream at the bottom of the well. The temperature was then shown in the display.

The temperature measurements were found to be highly erratic and the outcome hard to draw any conclusions from. This can probably be explained by the fact that the sewer system in Snogeröd is rather small and dictated to a relatively large extent by single household activities. Temperature in the flowing wastewater will thus be the subject of fast changes due to the highly intermittent conditions. The "pistol" could perhaps come to better use in a larger sewer network with stable flow patterns.

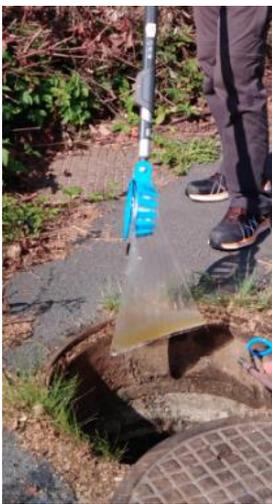
Figure 4. The fruit picker with the attached plastic bag. The plastic bag was inserted into the wastewater stream to collect samples.

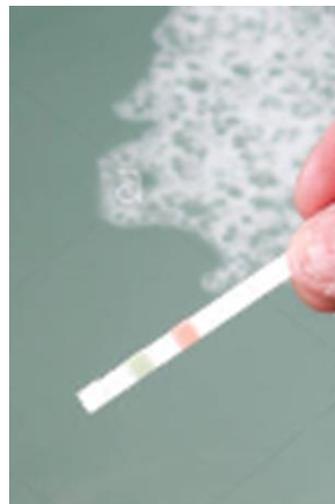
Figure 5. A quick analysis of the concentrations of ammonium and phosphate was carried out with test stripes.

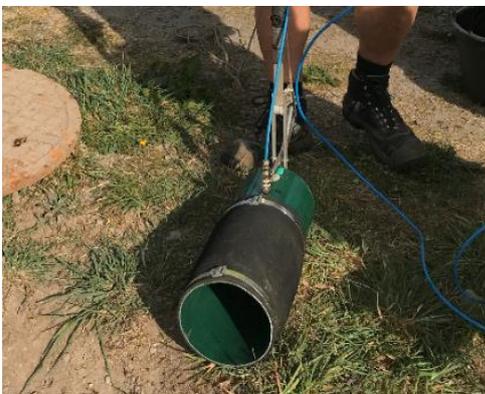
Figure 6. The measuring of flow using weirs.

The result from this study underlined the dangers in relying solely on ocular inspection. There are various ways to be fooled by flow, especially if one does not climb down into the wells. One should, at least, use a weir. However, even with this method there are dangers. As has been noted before, a small network has a highly irregular flow pattern and it could be enough with one wastewater-generating appliance to affect the results. Therefore, flow measurements on a town like Snogeröd should be carried out during night.

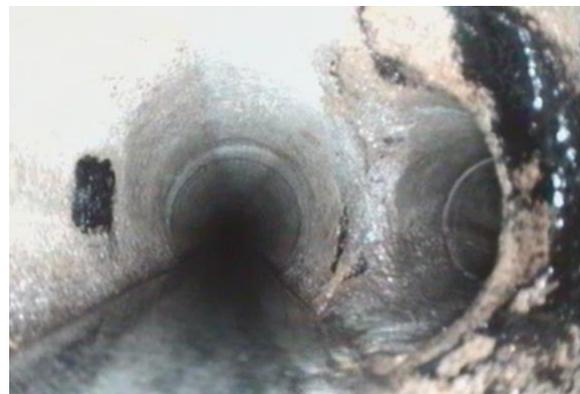
Figure 7. A TV-inspection was performed for the whole sewer network in Snogeröd

TV-inspection would seem like the most reliable method. However, it is costly. To perform similar inspections like the one carried out in this project are usually not feasible.
